AUDIT OF USAID/WEST BANK AND GAZA CONSTRUCTION PROGRAMS

AUDIT REPORT NO. 8-294-16-001-P
FEBRUARY 22, 2016

U.S. Army Corps of Engineers
Ft. Worth District/Northwestern Division

USAID AUDIT-WEST BANK, ISRAEL

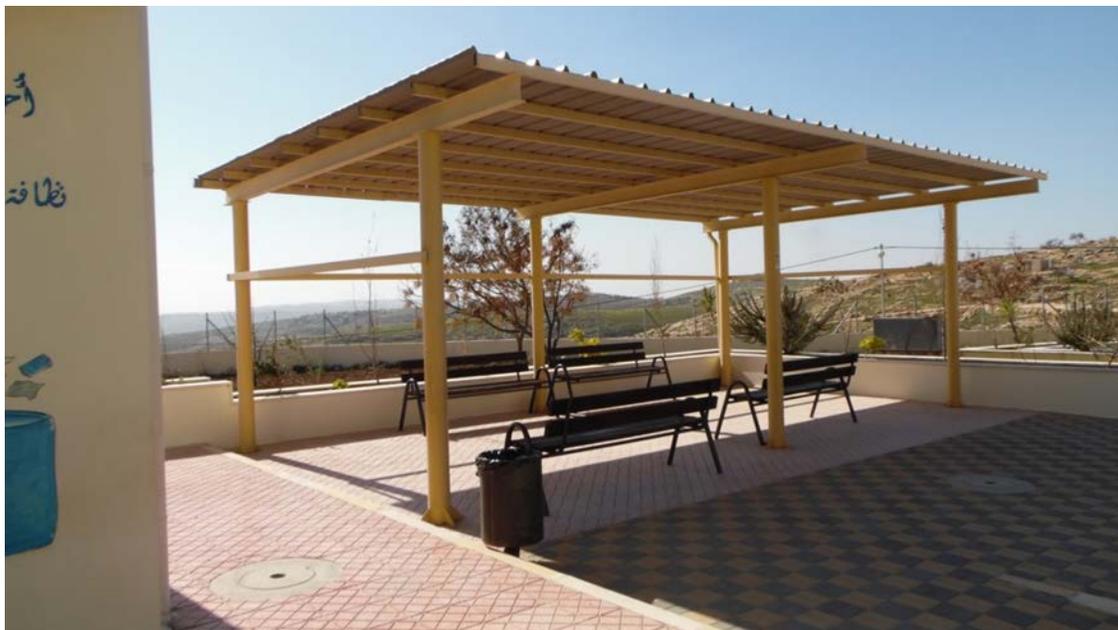
This shade area at Al Buweib Coeducational School was paid for by USAID. (Photo by RIG/Frankfurt, January 29, 2015)

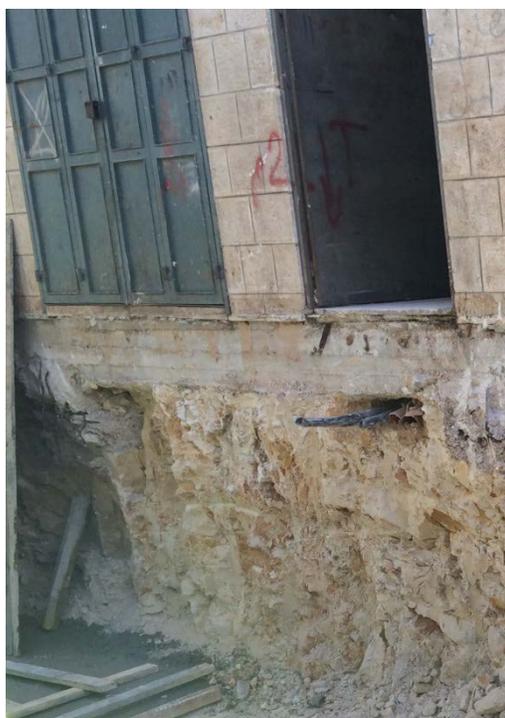
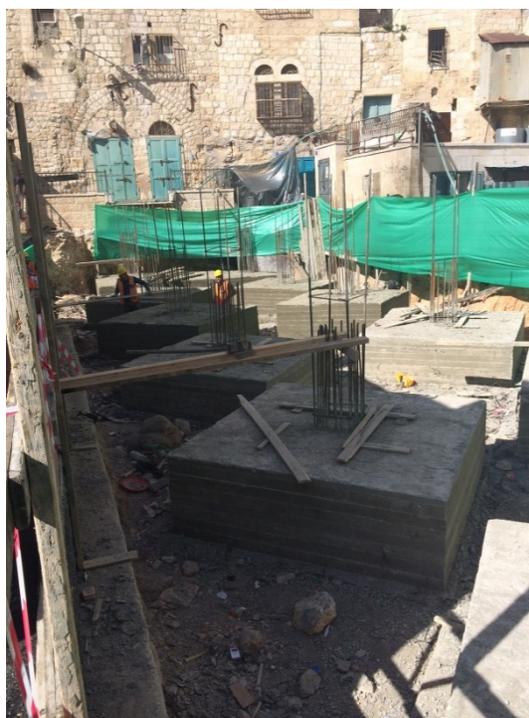
For example, the mission is renovating the Old Market in Bethlehem for more than \$2 million. This project is implemented through a cooperative agreement with American Near East Refugee Aid (ANERA), and the site is not subject to oversight provided by an A&E firm hired by the mission. Instead, ANERA’s engineers supervised the excavation, steel construction, and other work, and ANERA hired an A&E firm to support them. The construction staff did not seem to understand steel construction, however, and neither mission staff nor staff from ANERA knew which building standards were used. This substantially increased the risk that the quality of the work will be poor. In another example at this site, workers were excavating beneath a building, which could cause it to collapse.

USAID is paying for renovations of the Old Market in Bethlehem. The work includes excavating under an existing building, left, and building foundations (right) for large, metal shade structures. (Photos by RIG/Frankfurt, February 3, 2015)
