AUDIT OF USAID/WEST BANK AND GAZA CONSTRUCTION PROGRAMS

AUDIT REPORT NO. 8-294-16-001-P
FEBRUARY 22, 2016

U.S. Army Corps of Engineers
Ft. Worth District/Northwestern Division

USAID AUDIT-WEST BANK, ISRAEL

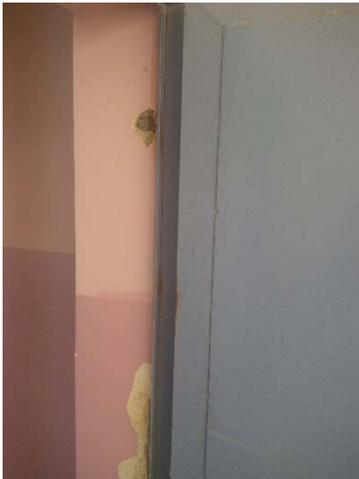
Photo 1

1. The paint is not adhering to walls in several locations (photo 1, 3, 4, 6, 10, 11, 13).
2. Metal works are rusting (photo 1, 5, 14).
3. The plaster is cracking at the masonry to column connections (photo 2, 12).
4. There are broken and missing drain grates (photo 3, 12).
5. A downspout is missing (photo 4).
6. Plaster is cracking on walls and at the parapet (photo 4, 6, 7, 9, 10).
7. There is no flashing at the parapet walls (photo 6, 7, 8, 9, 10).
8. The plaster and caulk is cracking at windows (photo 14).
9. Furniture is stored on roof (photo 8).

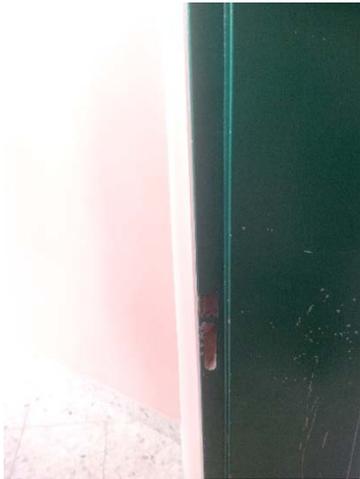
Photo 1

1. Missing door strikes (photo 1)
2. Missing and bent anchor bolts (photo 2)
3. Paint not adhering to walls (photos 3, 5, 6, 16, 17)
4. Improper installation of flashing at parapet walls (photos 4, 5, 6, 7, 10, 11, 12, 13, 14, 15)
5. Plaster cracking at parapet (photos 7, 8)
6. Missing roof drain grate (photo 12)

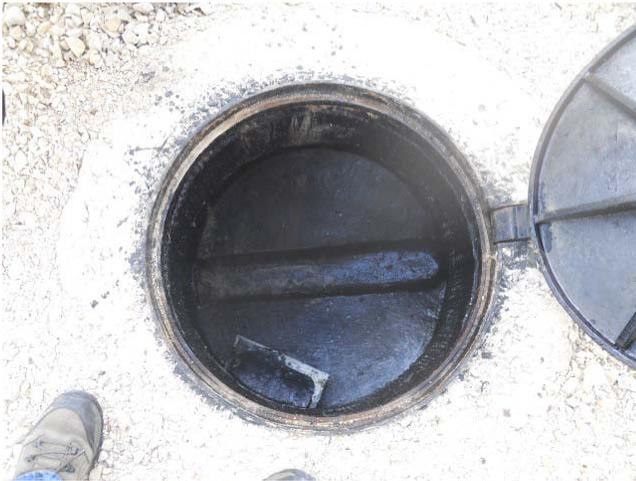
Photo 1

This work included supply and installation of 787 m of pipe, manholes and inlets. Work also included repair of pavement from excavation (see photos 1-2).
