AUDIT OF USAID/PAKISTAN'S GOMAL ZAM MULTIPURPOSE DAM PROJECT

AUDIT REPORT NO. G-391-12-008-P
AUGUST 24, 2012

ISLAMABAD, PAKISTAN

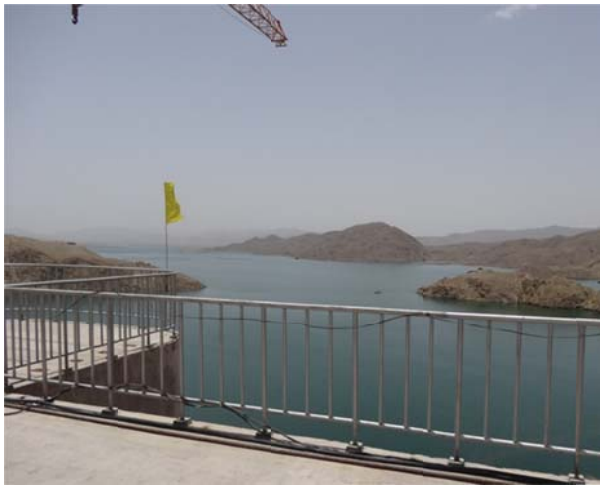
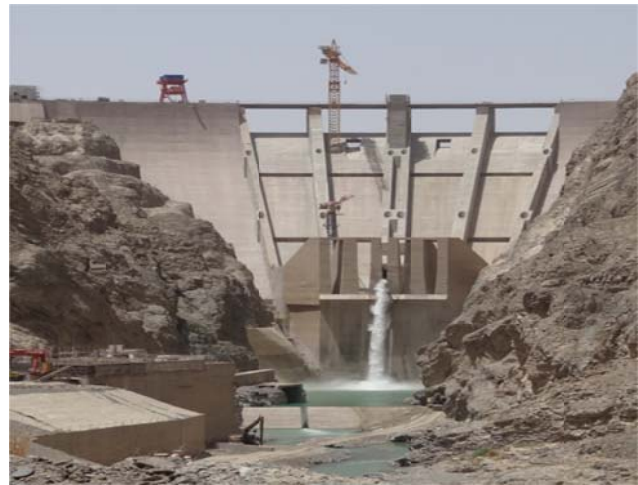
As of July 2012, USAID funding allowed for the completion of the main dam structure, testing of equipment, and assembly of 194 of 201 transmission towers from the dam site in South Waziristan to the grid station 55 kilometers east in Tank. The dam is designed to produce 17.4 megawatts of electricity, serving the needs of at least 25,000 households; at the time of OIG site visits, the water level in the reservoir (shown below) was at 81 meters or approximately 65 percent of capacity.

Water from the reservoir (left) pours through the dam (right). (Photos by OIG, June 2012)

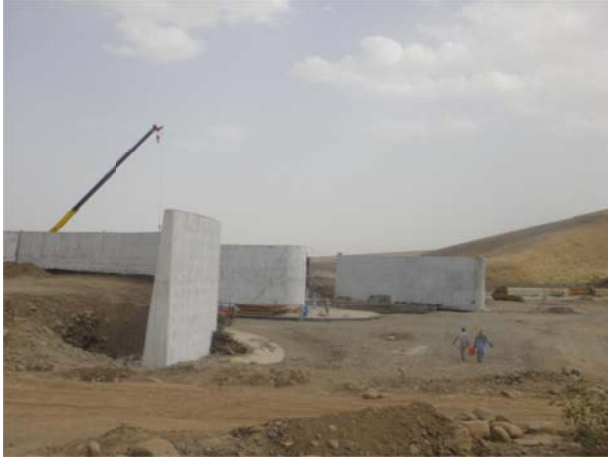
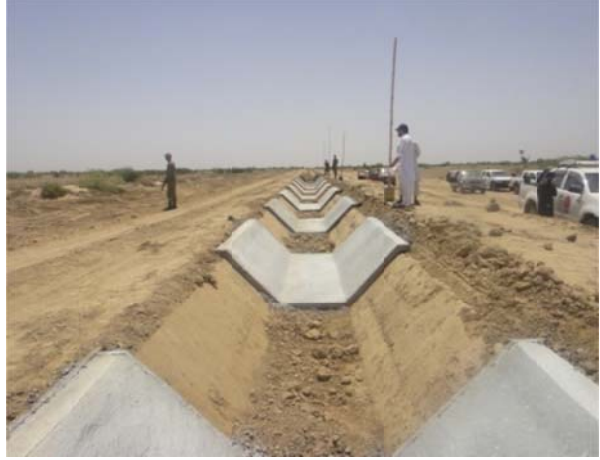
OIG discussed with local farmers the irrigation techniques they were using—like storing floodwater on the fields—and the drawbacks of these techniques. The reservoir and irrigation system being built (pictured on the next page) should make water available to farmers and help irrigate 163,000 acres of land, increasing the economic benefits of 30,000 households. Further, local stakeholders noted that, even while under construction, the dam protected the area in

Irrigation work under way includes a barrage for water diversion (left) and canal distributaries like the one above (right). (Photos by OIG, June 2012)

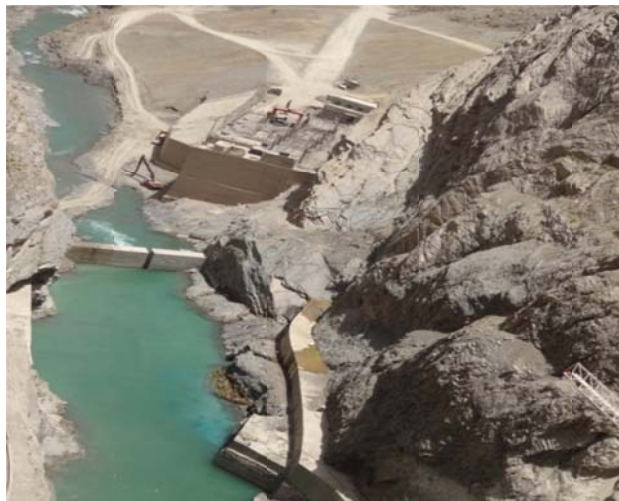
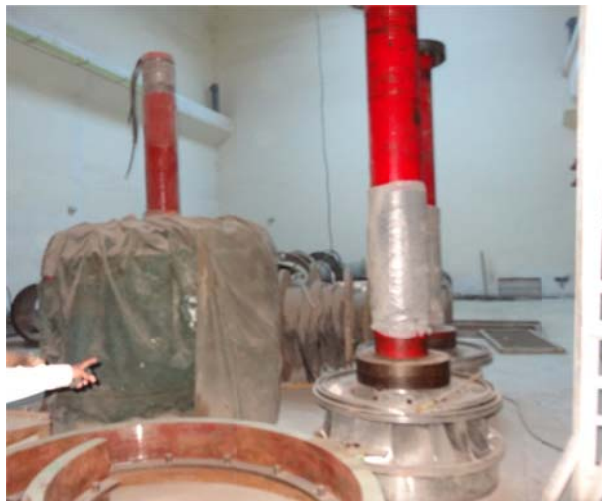
As of July 2012, the switchgear component had not been installed, and completion of the dam was at least 3 months behind schedule. During site visits, OIG observed that the switchyard structure, which contains the switchgear, was only partially built. Completing the switchyard and installing the switchgear component are necessary to begin generating electricity.

According to WAPDA officials, the switchyard was 91 percent complete when it was buried under a landslide caused by excessive rain in 2010. A new switchyard location was selected, and new equipment had to be ordered. Because the switchgear component is being custom-made outside the country, procuring it has taken more time than expected. Additionally, the subcontractor was still seeking compensation for an outstanding payment, and this was impeding progress. Further, the subcontractor had not reassembled the salvaged switchyard generating units (which were cleaned after the landslide), in spite of repeated instructions by WAPDA to do so.

WAPDA's delayed payment to its subcontractor is not covered by USAID funding; however, completing the switchyard and reassembling its components (shown below) are. WAPDA officials said they were working with the subcontractor to resolve these problems. Nevertheless, they estimated the interruptions have cost about \$10.5 million in labor, engineering fees, and security.

At left is the incomplete switchyard structure. At right uninstalled hydropower components wait inside the structure. (Photos by OIG, June 2012)

Recommendation 1. We recommend that USAID/Pakistan implement a coordinated action plan with Water and Power Development Authority for the timely completion of the dam.

Recommendation 1. USAID/Pakistan agreed to work with Water and Power Development Authority to implement a coordinated action plan by December 31, 2012, for completing the Gomal Zam Multipurpose Dam. Accordingly, a management decision has been reached on Recommendation 1.
